Bartlett & West

April 15, 2021

Re: Bridge No. 2740017 – Swinging Bridges Road over Grand Auglaize Creek
Bridge Engineering Assistance Program (BEAP) Report – 21TTAP-32

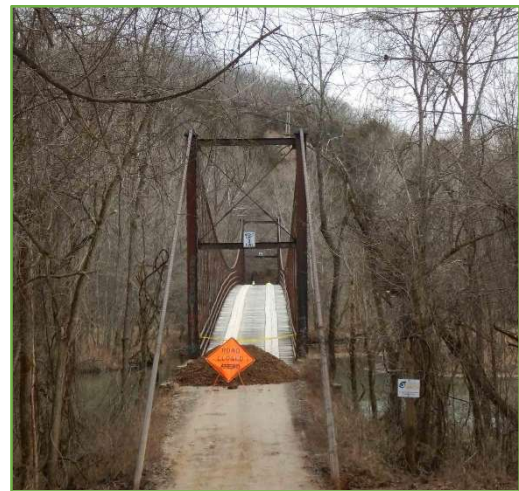
Figure 1 – Narrow unpaved approach to historic Grand Auglaize swinging bridge. (MoDOT photo)

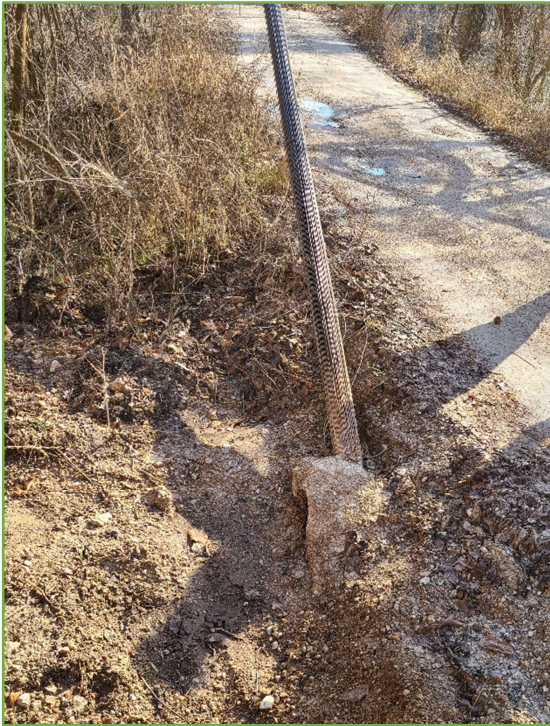
Figure 2 – Concrete anchorage at northwest corner of the bridge is being compromised by deterioration so new reinforced concrete anchorage must be constructed.

2. The concrete anchorages at the west end of the bridge should be replaced, likely one at a time but depending on the Contractor's specific means and methods. Each new concrete anchorage could be constructed in the same spot as the existing anchorage if the main cable were temporarily held in place and cable tension maintained until the removal and reconstruction activities for the anchorage were complete. The Contractor could maintain the cable tension if they were able to clamp or otherwise attach to the bundled wires in the main cable and prevent movement with a deadman system or very large stationary mass. Alternatively, the new concrete anchorages could be constructed adjacent to the existing anchorages and located closer to the creek. This option would make the new west-end anchorages more visually apparent, but they would be similar to the bridge's east-end anchorages, the anchorages of the Mill Creek bridge, and those of the Warsaw Upper Bridge.

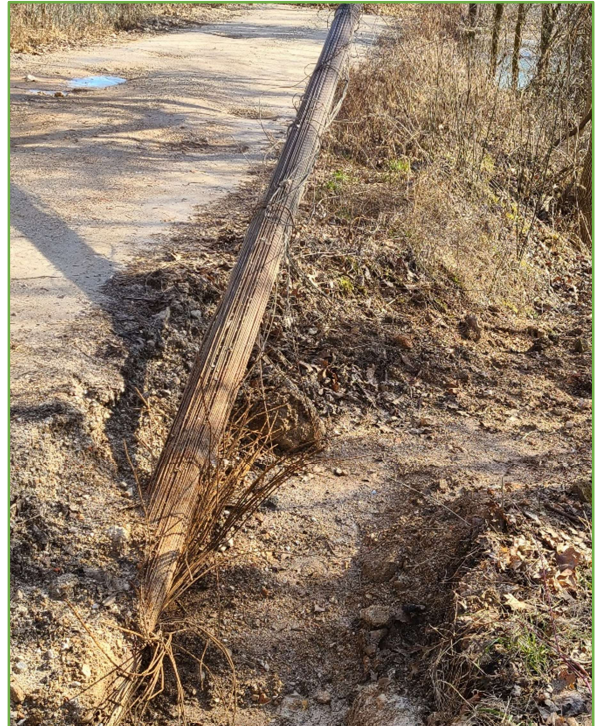
Figure 3 – Concrete anchorage at southwest corner of bridge is being compromised by deterioration so new reinforced concrete anchorage must be constructed.

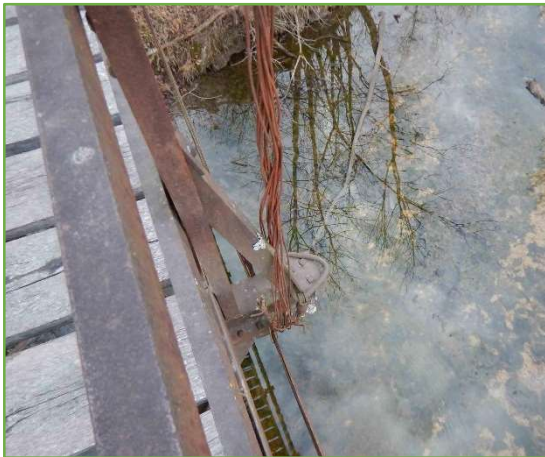
Figure 4 – Attachment details at top and bottom of replacement hanger cables can be improved. Rub-guard or saddle would slow the section loss in wires and floor beams. (MoDOT photo)

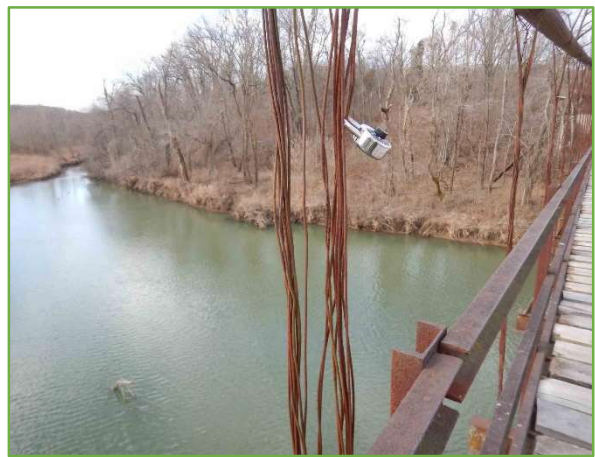
Figure 5 – Some hanger cables have become untwisted and lost tension; others have section loss or breakage in individual wires. (MoDOT photo)

5. Replace approximately 11% of the 164 hanger cables. Recent observations place the current number of hangers that definitely need replacement at 9. With time passing and to accommodate the fact that typical bridge rehabilitation projects commonly encounter quantity overruns, the cost estimate accounts for 18 hangers being replaced or repositioned. These replaced and repaired hanger cables need to have their tension measured by observing the natural frequency of each and correlating it to tension. Further adjustments may then be necessary.

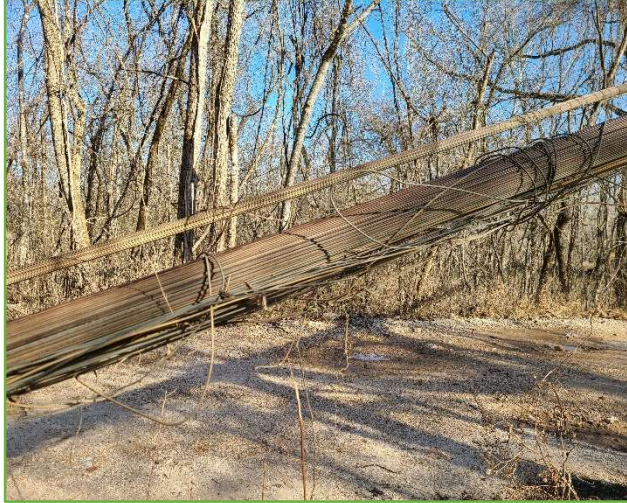
Figure 6 – Loose and broken outer wires are becoming more prevalent thus exposing the inner core and increasing the risk of being compromised.

1. Replace, splice or otherwise repair individual wires in each main cable. The exact number of wires can be determined during final bridge design as it is outside the scope of this BEAP study. Because the ends of the main cables are to be encased in concrete anchorages, the Contractor will have to coordinate the repair work on the main cables with that on the concrete anchorages.

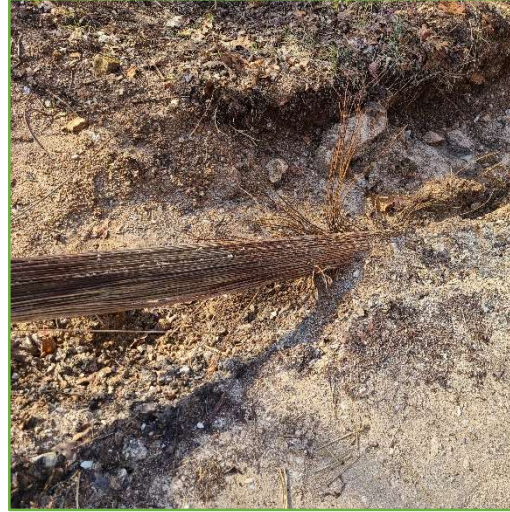
Figure 7 – Main cables at west anchorages no longer have outer wrap wires around a tightly bound core of individual wires.

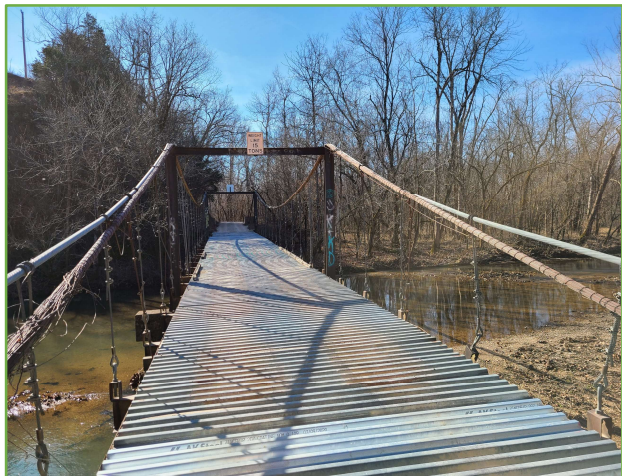
4. AASHTO 2020's historic bridge preservation document indicates that on some other historic suspension bridge projects, additional main cables have been added adjacent to the existing cables and with their own hanger cables, just like the work done in 1979 to the nearby Mill Creek bridge shown in Figure 8.

Figure 8 – Nearby Mill Creek bridge with 15 ton load limit was repaired in 1979 with new main cables, suspender cables, concrete anchorages and corrugated metal deck.

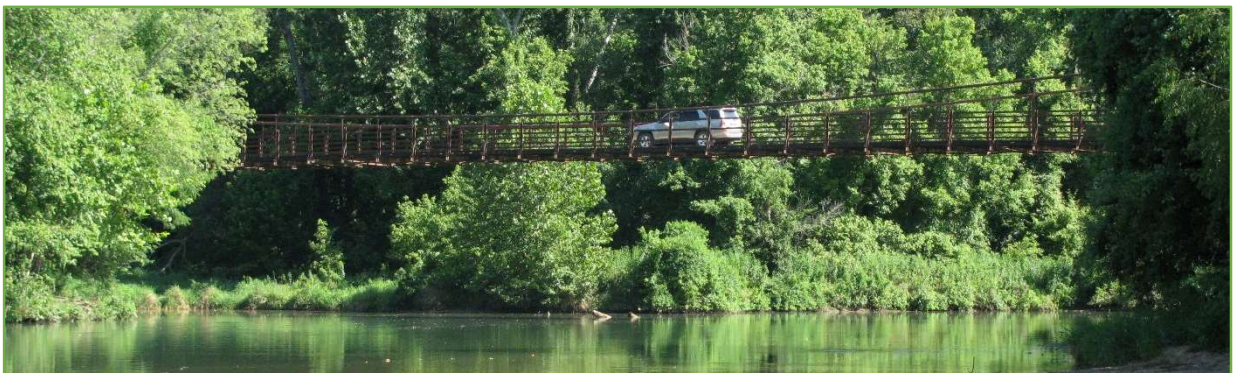
Figure 9 – Single lane bridge's railing system consists of three horizontal rails between vertical steel posts.

3. Repair the bridge railing where welds in the steel have cracked.

5. Use a Design Exception document signed by the Engineer of Record, Owner and possibly other stakeholders stating the bridge railings are acceptable for the conditions found at this site.
