BRIDGE ENGINEERING ASSISTANCE PROGRAM

BEAP Project Number: 20TTAP-11

MILLER COUNTY BRIDGE No. 2740017
on SWINGING BRIDGE ROAD over GRAND AUGLAIZE
S36, T39N, R15W

OCTOBER 24, 2019

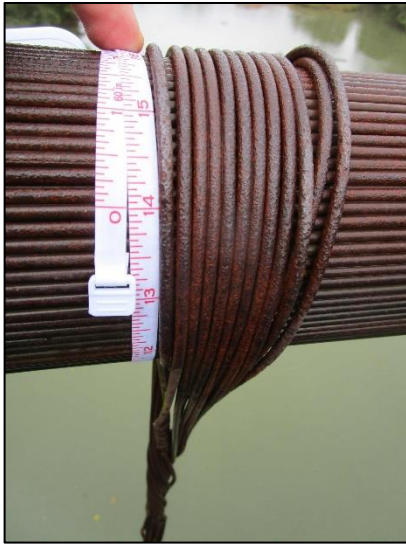
A circumference of 14" was determined for each main suspension cable with each wire approximately 0.15" in diameter. With AutoCAD's assistance, there is estimated to be approximately 740 wires included in each suspension cable. With 52 wires broken, this accounts for a 7% loss in capacity.

Main Cable 14" Diameter

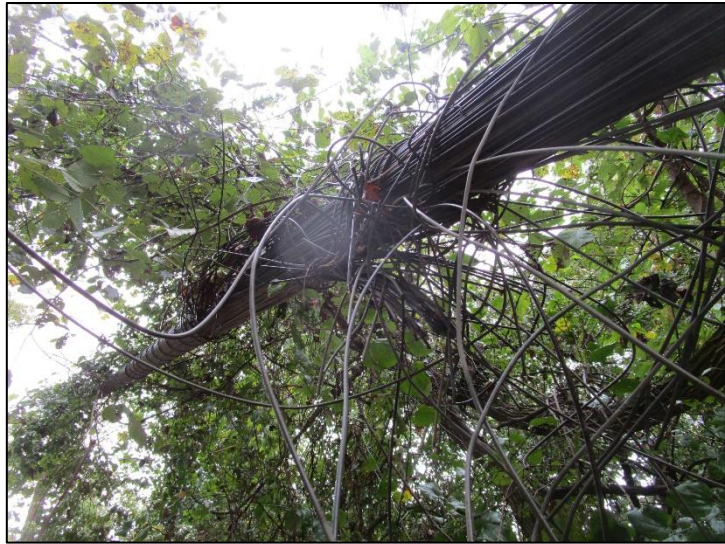
According to the 2018 FCB report, the south main cable has several broken wires at the west anchor. During our visit, we observed approximately 52 broken wires near the southwest main suspension cable anchor. There is additional corrosion at grade.

Southwest Main Cable Anchor-52 broken wires

The main suspension cable member has approximately 7% capacity reduction with 52 of the ~740 wires broken at its worst location near the southwest anchor. Although continued deterioration should be monitored, this member does not currently control the load rating.

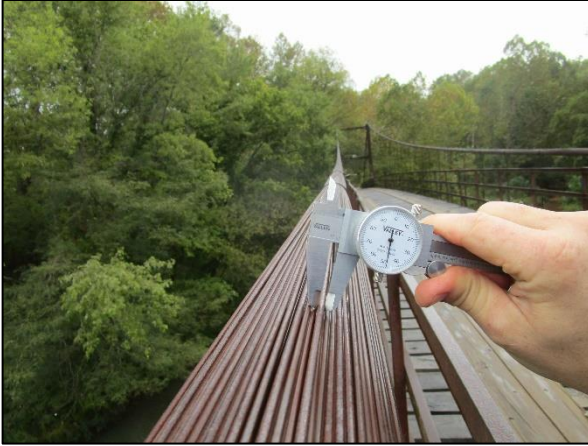
Main Cable 0.15" Diameter Wires

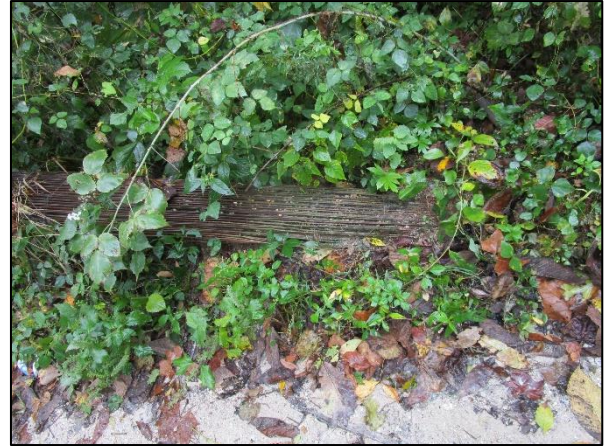
Southwest Main Cable Anchor at Grade

The west main suspension cable anchors show signs of corrosion at grade. It is anticipated more wires may fail and may be necessary to review preventative options to reduce this corrosion or increase the concrete anchorage.

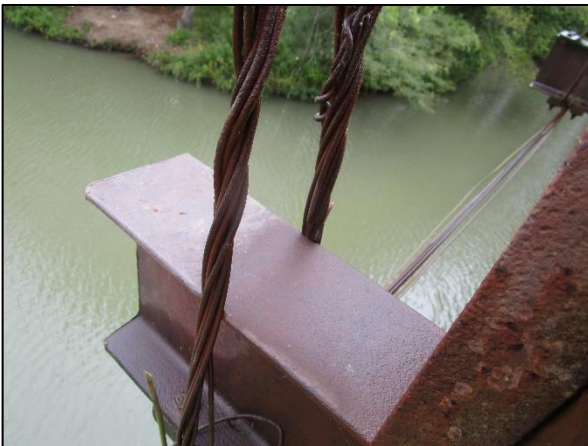
There are 20 wires (10 loops) in each hanger wire assembly at each floorbeam end with each wire approximately 0.15" in diameter. The 20 wires are twisted together and secured laterally by the main suspension cable's soft wrap. The inner wire strands rub the top flange of the floorbeam resulting in severe section loss and wire failure.

Hanger rubbing on Floorbeam Flange

The hanger wire assemblies control the load rating. Nearly all hanger assemblies have an issue to be addressed, whether it is heavy pitting, cut or worn from floorbeam top flanges, untwisted, slack or misaligned. As mentioned above, **9 hanger wire assemblies control** with an equivalent of 7 or more broken wires in a 20-wire hanger assembly. This results in a load posting below 5-ton.

The **first recommendation is to replace 9 controlling hanger assemblies** which immediately restrict the bridge from being posted at 5 tons. The immediate controlling hanger assemblies include:

The **second recommendation is to replace all hanger assemblies**. Most hanger wires remain from original construction and approximately 68 additional hanger assemblies are likely to reduce the load posting back to 3 ton in a short time frame from the deterioration documented in the 2018 FCB inspection report. It may be beneficial to replace all hanger wires at one time to match original construction.

To match the original construction, the new hanger assemblies shall be 20 (10 loops) #9-gauge wires twisted taught, aligned vertically and attachment to match original method (floorbeam to main suspension cable). In addition to original hanger assembly replacement, a rub-guard or saddle may be added to the floorbeam's top flange to reduce section loss to the rubbing wires. An alternative replacement material to original wire construction is to use 1 loop of 5/8" diameter, 6x19, galvanized wire rope.

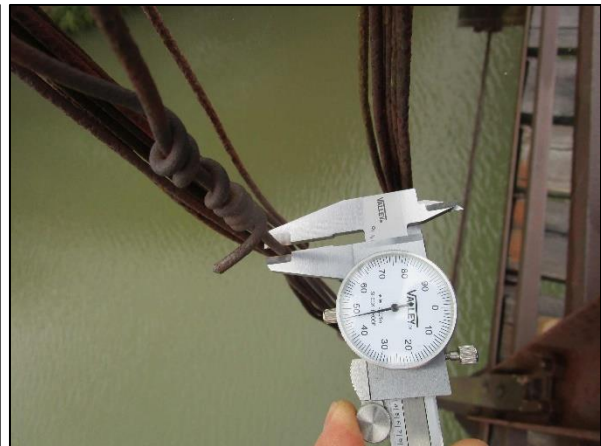
Hanger 0.15" Diameter Wires

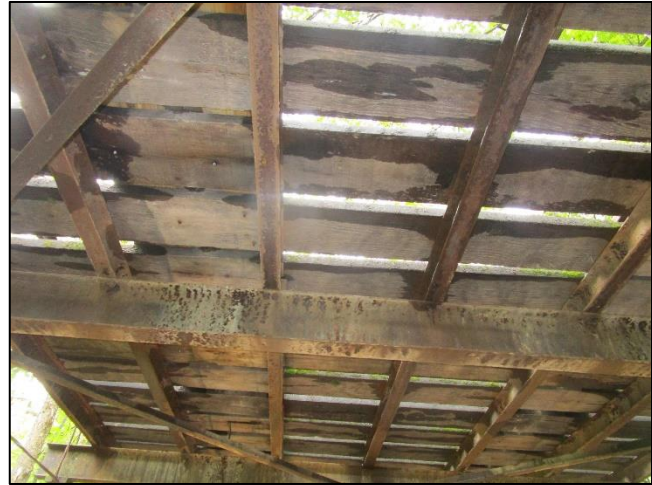
The stringers are not fracture critical, but are critical to traffic if undersized. Their fixity is staggered continuous and simply supported over 6ft spaced floorbeams. The 4" tall stringers are spaced at approximately 2' centers and support the timber deck.

With 2 exterior C4x5.4 stringers and 5 interior S4x7.7 stringers spanning 6', the shallow stringers are controlling member candidates.

Stringers

As mentioned, the stringers are not fracture critical, but due to size, they are the next controlling member after hanger wires. A live load distribution factor using LFD design allows the internal stringer to support approximately 40% of the load while distributing the other 60% to adjacent stringers. The stringers should be monitored for continued deterioration and lack of edge distance at floorbeam top flanges connections.

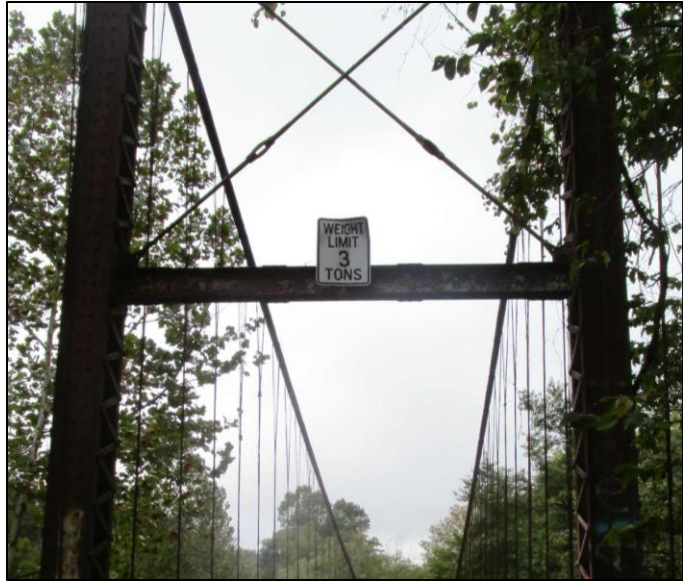
In our recent 2019 BEAP site visit, the 3-ton load posting was confirmed and the sign matched the sign in the 2018 FCB photos.

Posted 3 Tons

Therefore, **the current 3-ton load posting shall remain until repairs are performed.** See section 6.0 for repair recommendations.

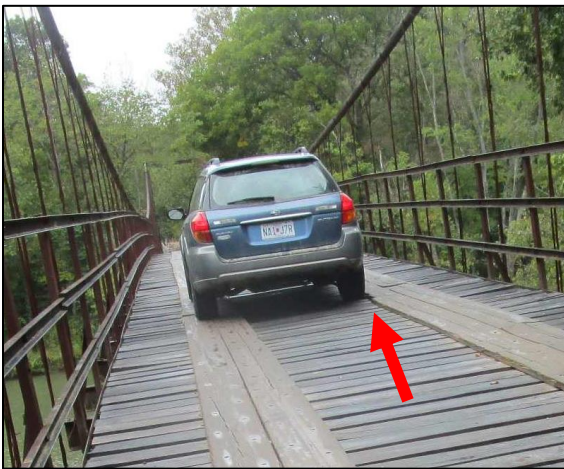
Wheel Line Width

An additional recommendation is to **add another timber runner to each wheel line** along the interior of each runner. During our visit, we witnessed several vehicles with insufficient wheel spacing to remain on both timber runners. It is recommended each timber runner be widened from ~24" to ~36".

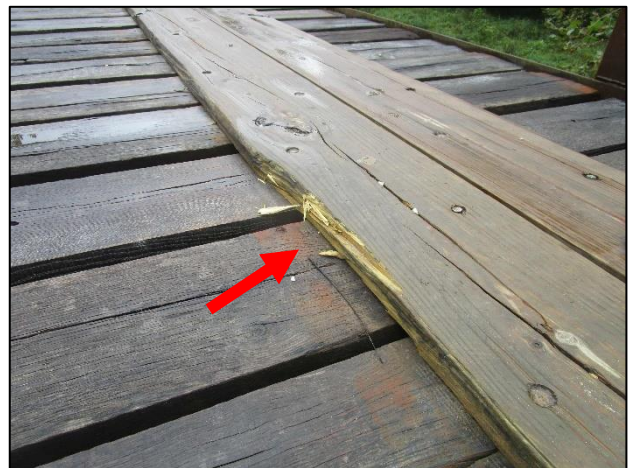
Runner Damage due to width

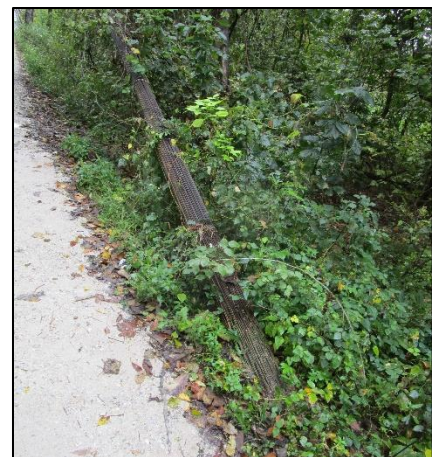
Vegetation at Anchor

It is also recommended to **remove or cut back vegetation** from around the bridge to allow moisture to escape.
