**FRACTURE CRITICAL INSPECTION REPORT
BRIDGE 2740017
MILLER COUNTY, MISSOURI
SWINGING BRIDGE ROAD OVER GRAND AUGLAIZE**

Prepared for the Missouri Department of Transportation
and
Miller County Commission
September 17, 2018

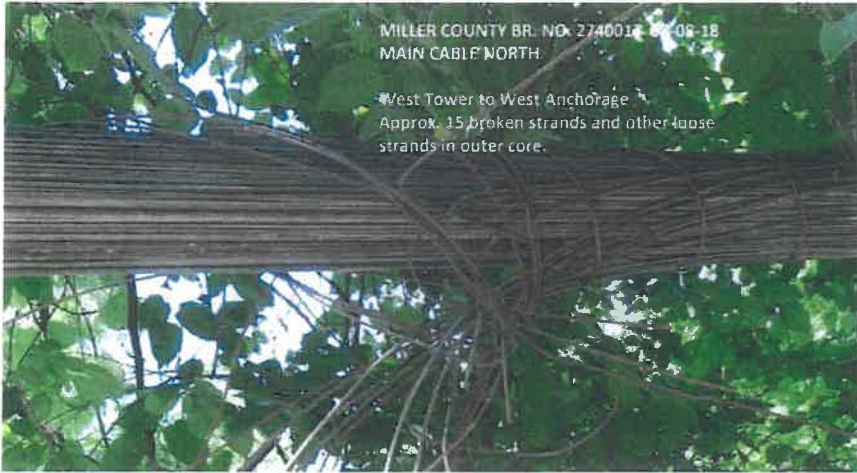
At the far west end, in the segment between the anchor block and last hanger (H82), there is the largest concentration of broken and/or loose strands. The south main cable, approximately 10 feet from the

anchor, includes in excess of 40 loose strands which are not bound by any wrapping. In close proximity to that grouping, about 24 strands are observed to be severed. At the anchor itself, the interface looks good, but there are about 12 broken strands noted. In the corresponding cable to the north,

approximately 20 feet from the anchor, there are about 15 observed broken strands. The area of draping over the towers looks good. This would be locations corresponding to U14U15 and also immediately to the west of U82. There are a few observed broken cables over the saddles at U82. Strands in the saddle at U14U15 have been spliced in the past.

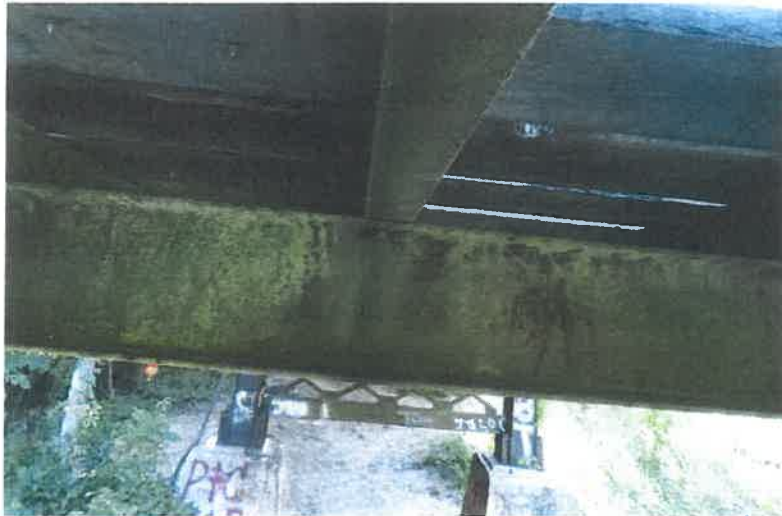
Typical condition of floor beams.

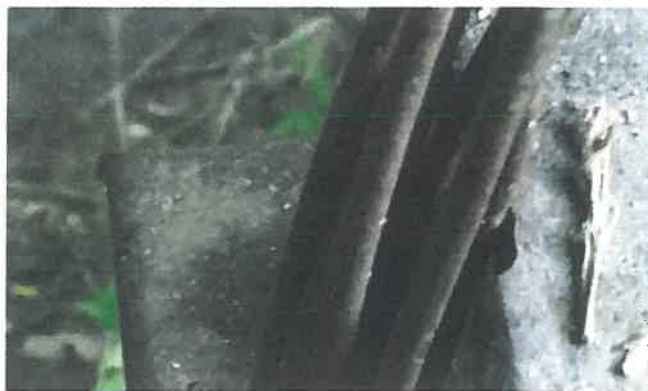
Note: gouge in top flange of floor beam 1 at hanger cable.
This is one of the more extreme cases of gouging.

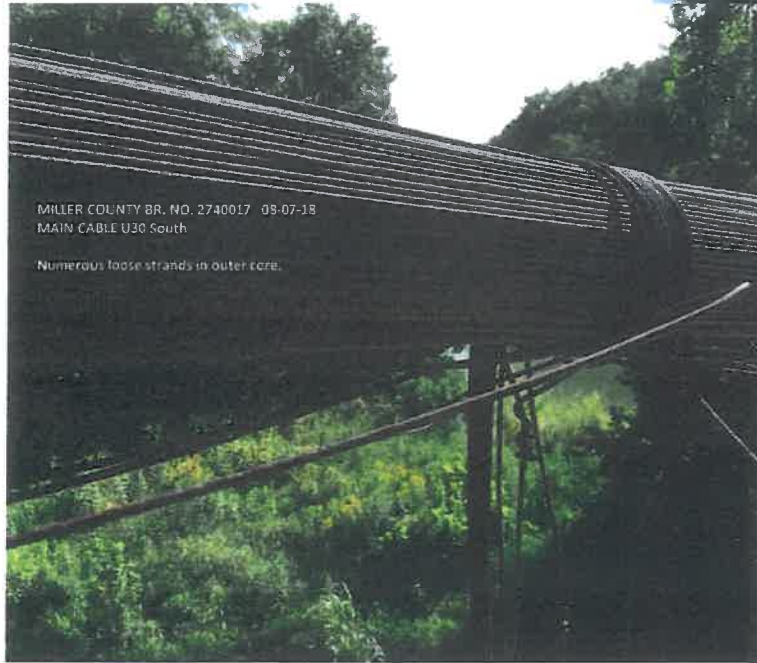
MILLER COUNTY BR. NO. 2740017 08-07-18
MAIN CABLE U30 South
Numerous loose strands in outer core.

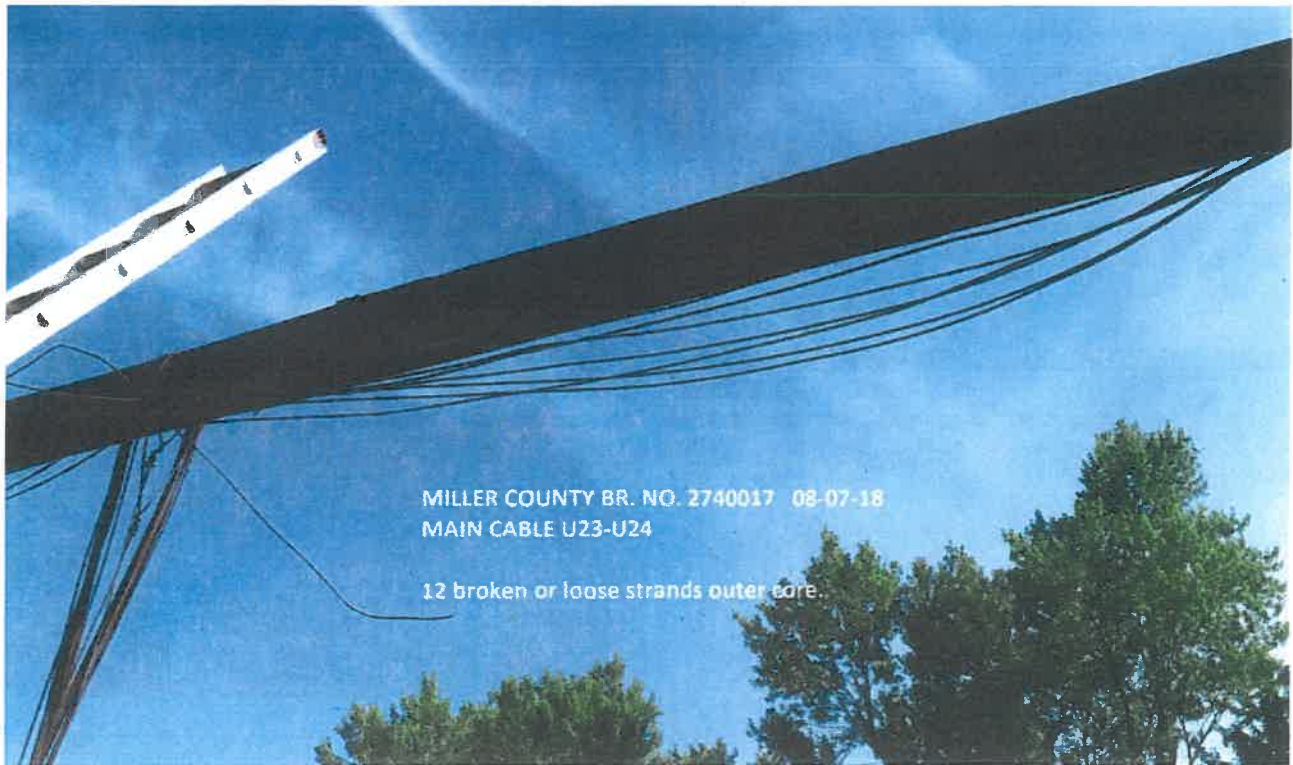
UPPER	NORTH	SOUTH
U12-U13		
U13-U14	3 broken/loose strands in outer core.	
U14-U15	3 broken/loose strands in outer core. Tower in between. Saddle area looks good.	Tower in between. Saddle area looks good.
U15-U16		
U16-U17		
U17-U18		
U18-U19		
U19-U20	6 loose strands in outer core (top).	
U20-U21		
U21-U22	12 broken/loose strands in outer core (bottom).	
U22-U23	12 broken/loose strands in outer core.	12 broken strands (bottom) at U23.
U23-U24	12 broken/loose strands in outer core.	14 loose/hanging strands.

MILLER COUNTY BR. NO. 2740017 08-07-18
MAIN CABLE U23-U24
12 broken or loose strands outer core.

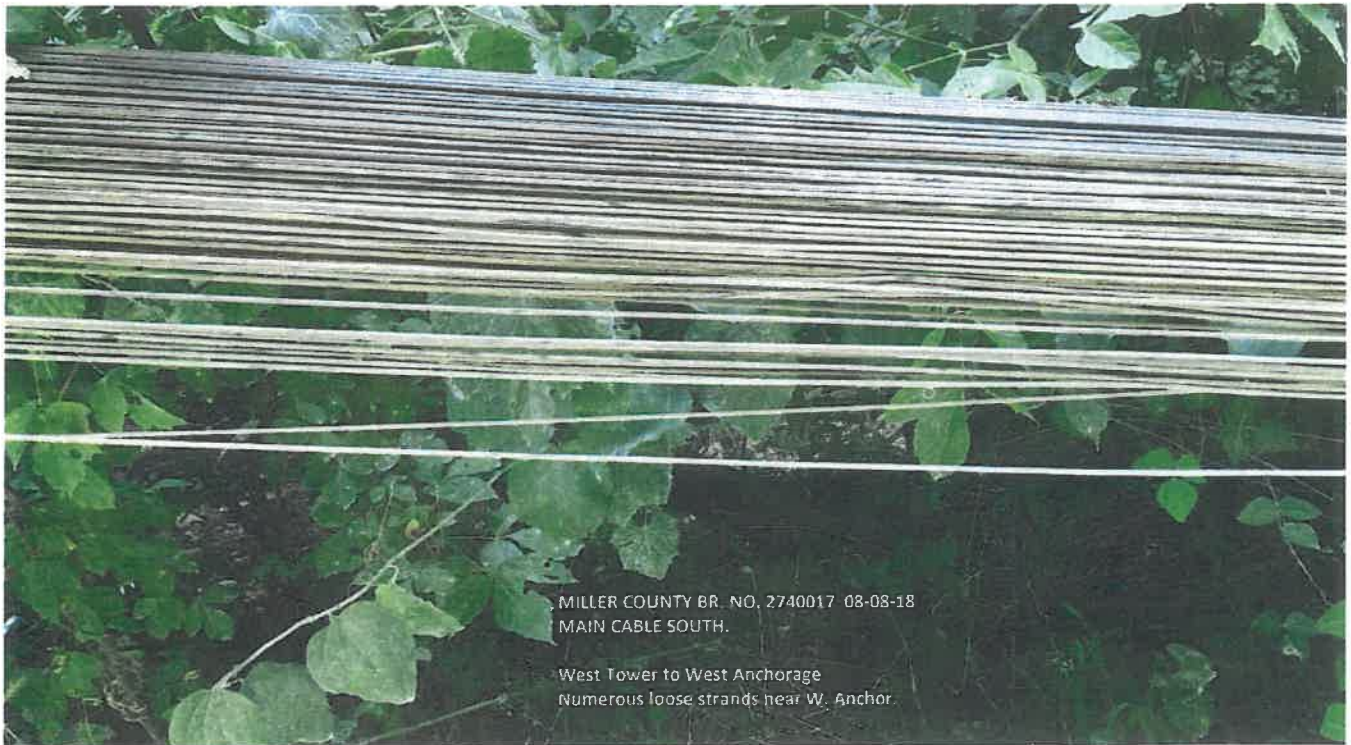
MILLER COUNTY BR. NO. 2740017 08-08-18
MAIN CABLE SOUTH.

West Tower to West Anchorage
Numerous loose strands near W. Anchor.

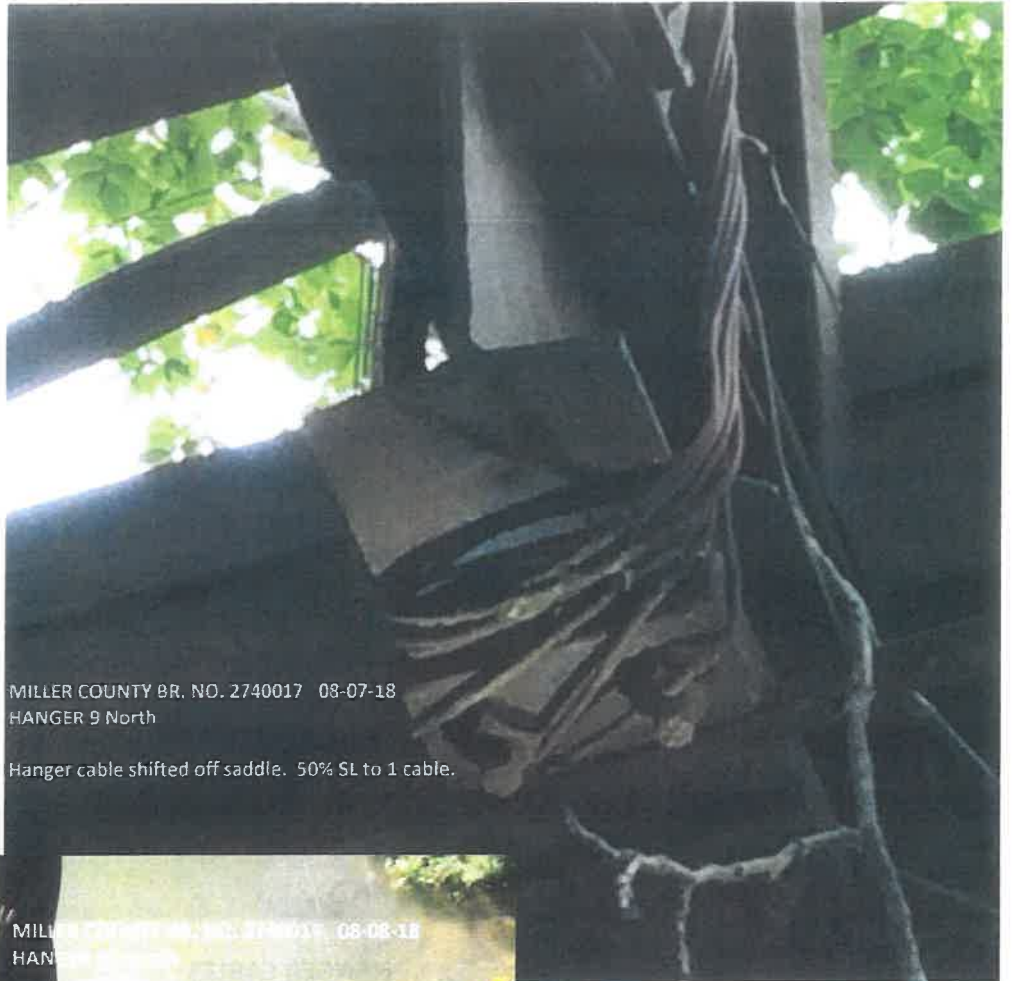
MILLER COUNTY BR. NO. 2740017 08-07-18
HANGER 9 North

H8	1 broken strand - bottom. 75% section loss in 1 strand (TFFB). Cable is tight.	50% section loss in 1 strand (TFFB). Cable is untwisted but tight.
H9	Saddle wrap around bottom of floor beam has shifted. 50% section loss in 1 strand. Cable is loose.	50% section loss in 3 strands. Cable is loose.
H10	50% section loss in 3 strands Cable is untwisting but taught.	50% section loss in 3 strands. Cable is untwisting and loose.
H11	50% section loss in 3 strands Cable is loose.	Cable is untwisting and taught.
H12	Minor wear in 3 strands. Cable is tight.	50% section loss in 3 strands. Various parts of cable untwisting. Cable is loose.

Hanger cable shifted off saddle. 50% SL to 1 cable.

Review Fracture Critical Inspection Spreadsheet and consider replacing or retrofitting those vertical hanger locations with observed wire breaks.

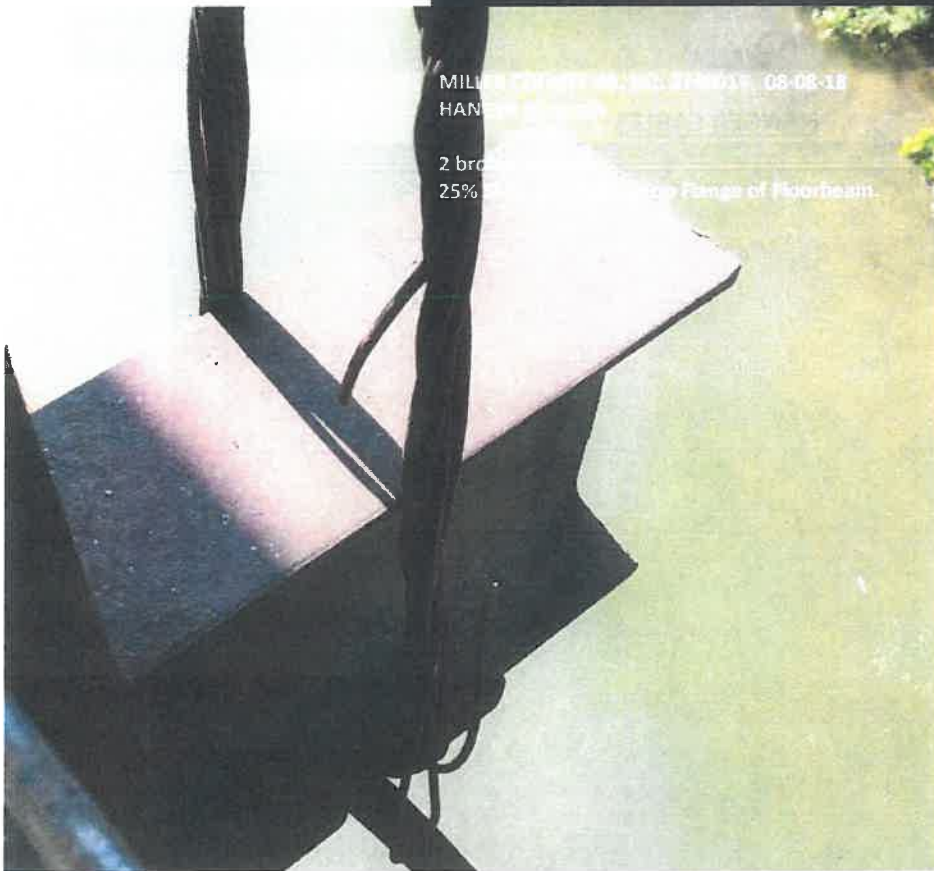
MILLER COUNTY BR. NO. 2740017 08-08-18
HANGER 9 North

2 broad cables 25% SL to edge of floorbeam.

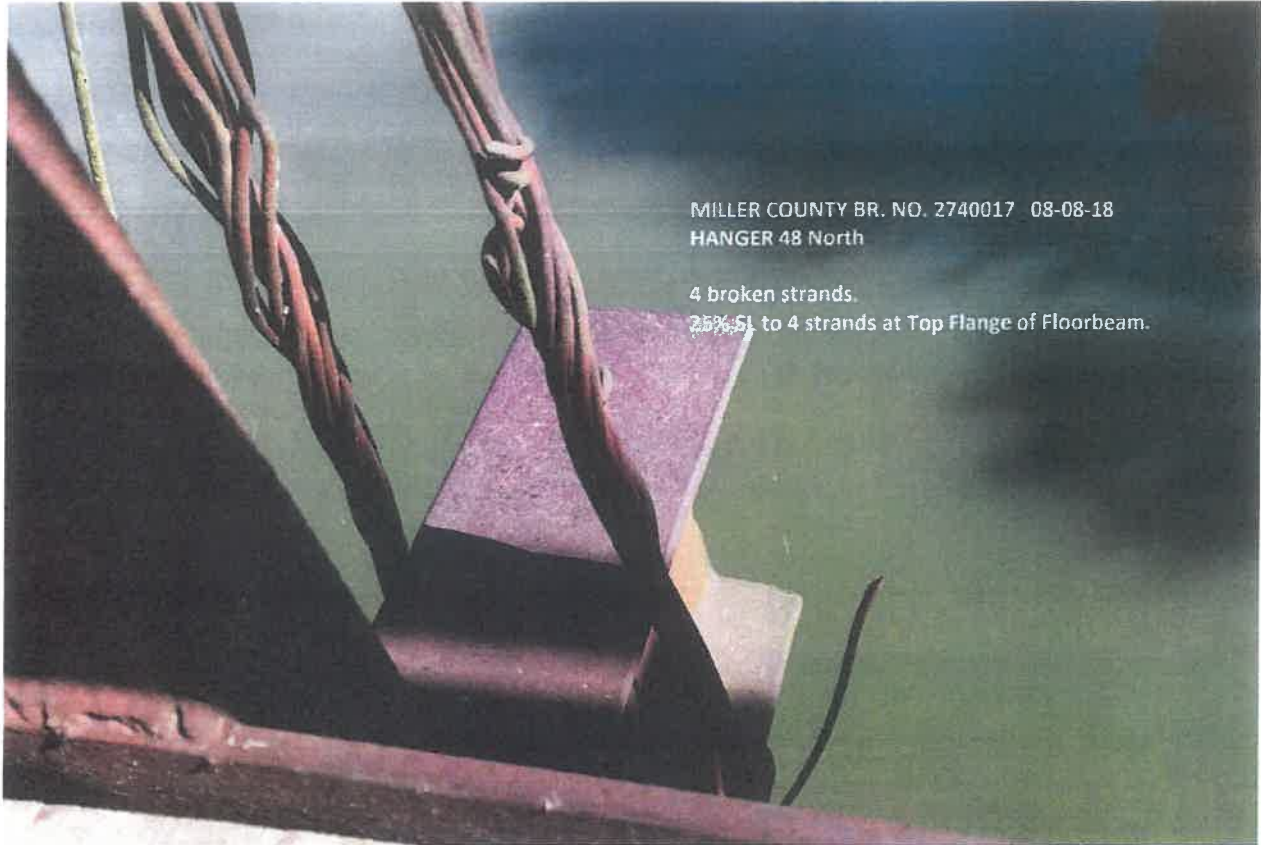
MILLER COUNTY BR. NO. 2740017 08-08-18
HANGER 48 North

4 broken strands.
25% SL to 4 strands at Top Flange of Floorbeam.

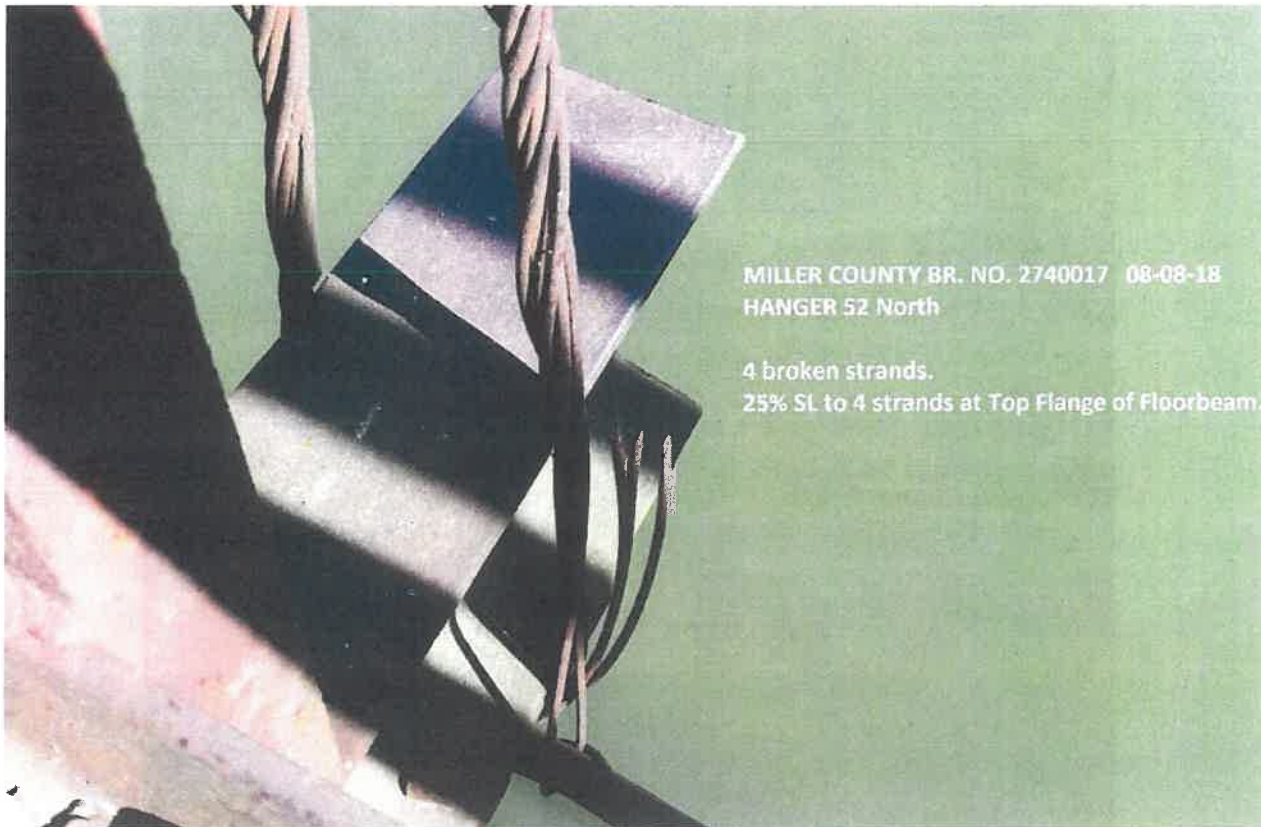
MILLER COUNTY BR. NO. 2740017 08-08-18
HANGER 52 North

4 broken strands.
25% SL to 4 strands at Top Flange of Floorbeam.

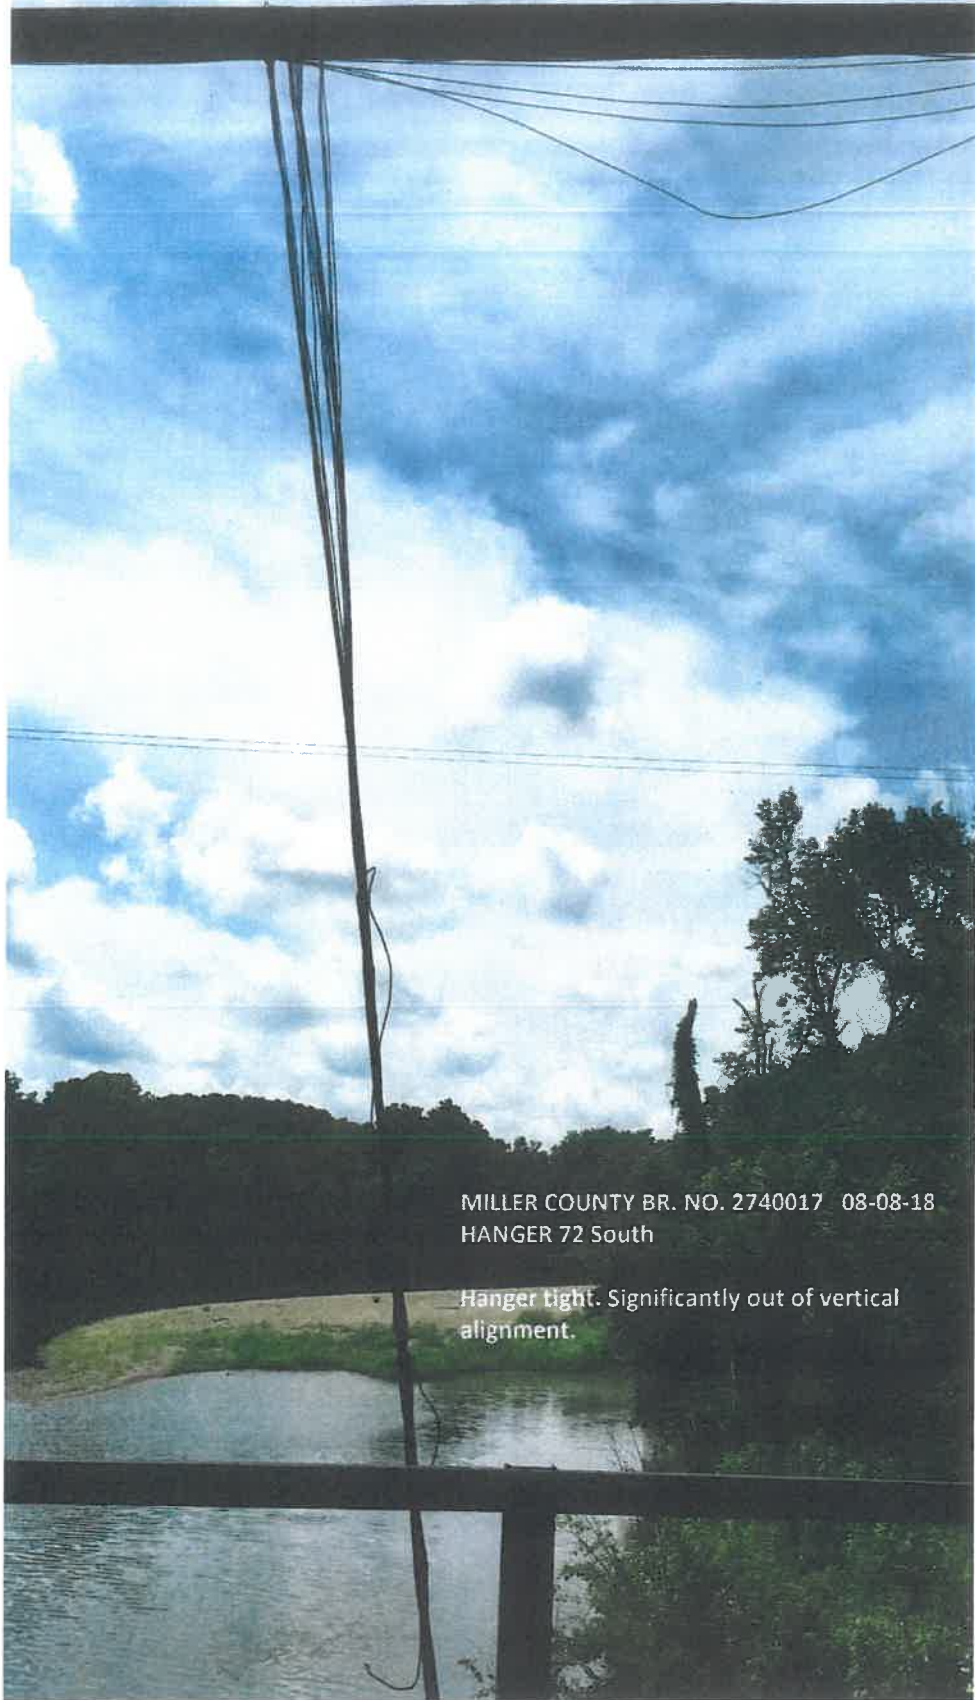
MILLER COUNTY BR. NO. 2740017 08-08-18
HANGER 72 South

H71	25% general section loss in upper hangers. Cable is loose, untwisted.	25% section loss in upper hangers. 25% section loss in 2 strands (TFFB). Cable is taught, untwisted.
H72	20% general section loss in upper hangers. Cable is loose.	1 broken strand - top and bottom. 25% section loss in upper hangers. 25% section loss in 1 strand (TFFB). Cable is taught, but way out of alignment.

Hanger tight. Significantly out of vertical alignment.

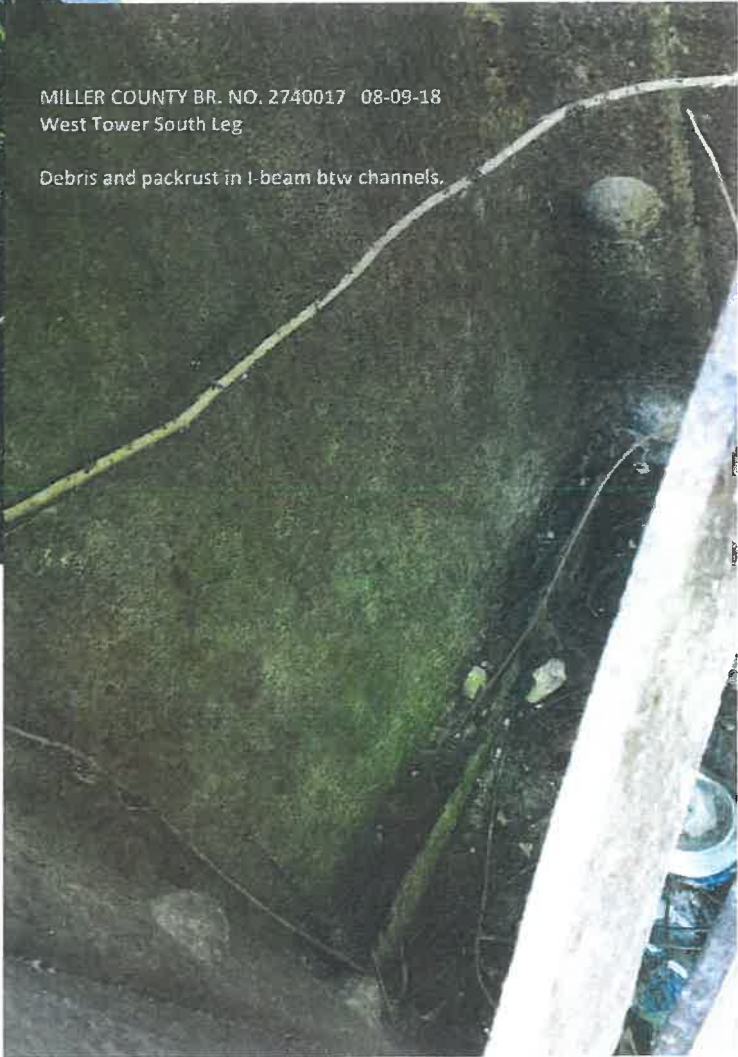
MILLER COUNTY BR. NO. 2740017 08-09-18
West Tower South Leg

Debris and packrust in I-beam btw channels.

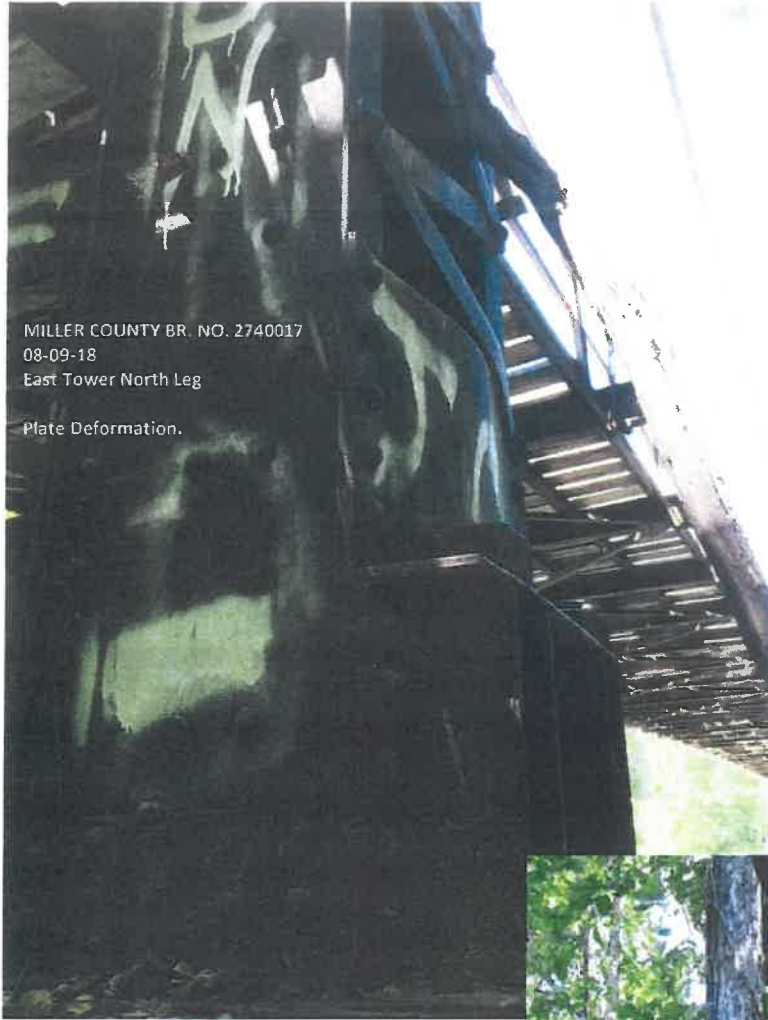
MILLER COUNTY BR. NO. 2740017
08-09-18
East Tower North Leg
Plate Deformation.

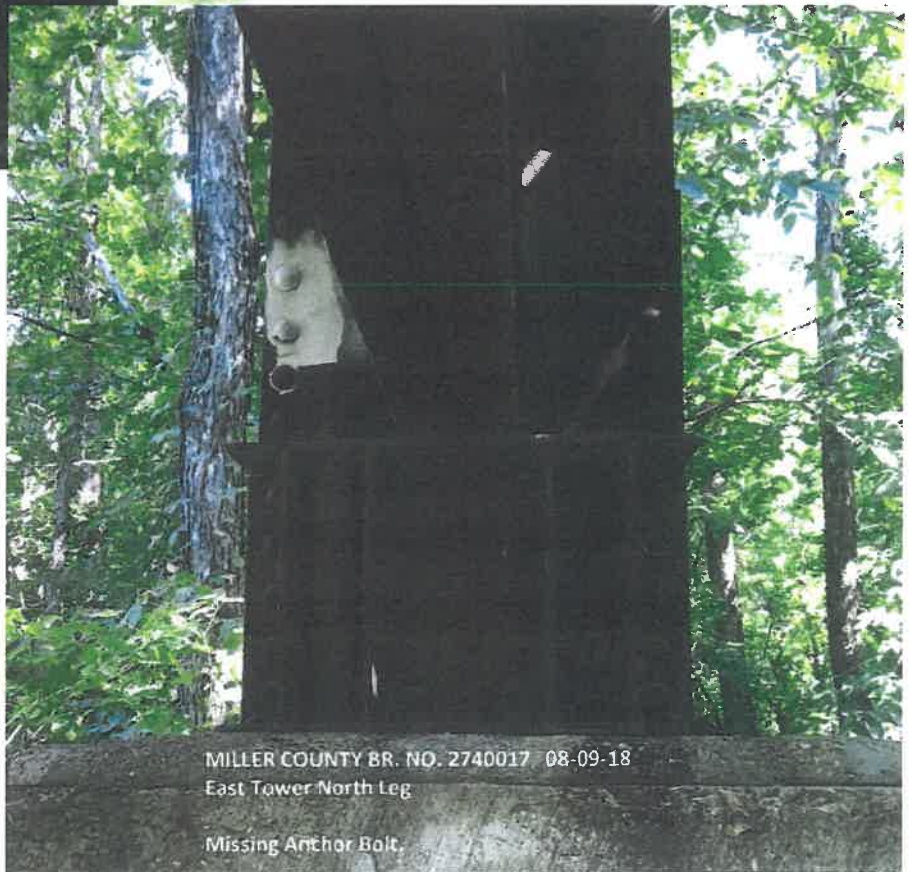
The suspension towers are not fracture critical. They have general rusting and minor pitting. A cursory review of the towers indicates there are isolated areas of moderate to heavy section loss in plating, lattice and connection angles. The towers are for the most part plumb. There is also a missing anchor bolt in the base of tower 1.

MILLER COUNTY BR. NO. 2740017 08-09-18
East Tower North Leg
Missing Anchor Bolt.
