BRIDGE ENGINEERING ASSISTANCE PROGRAM

BEAP Project Number: 20TTAP-11

MILLER COUNTY BRIDGE No. 2740017
on SWINGING BRIDGE ROAD over GRAND AUGLAIZE
S36, T39N, R15W

OCTOBER 24, 2019

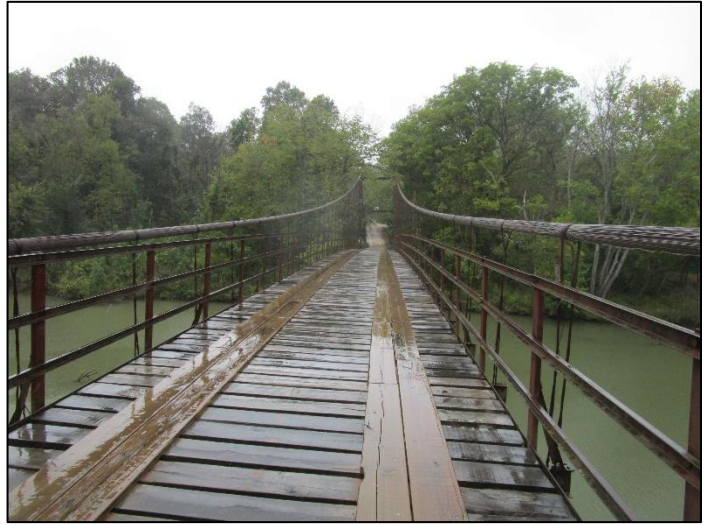
Miller Co Bridge No. 2740017

During our visit to the site, we observed the controlling members according to the 2018 FCB report. The bridge is suspended by 2 main suspension cables spanning between towers and anchoring to grade at each end. The east suspension cables anchor over an approach span making this bridge a 2-span suspension structure. A hanger assembly suspends from these main suspension cables, which provides floorbeam and stringer support for the timber deck.
